REPORT OF INVESTIGATIONS/1993

## Evaluation of Catalyzed Diesel Particulate Filters Used in an Underground Metal Mine

**Report of Investigations 9478**

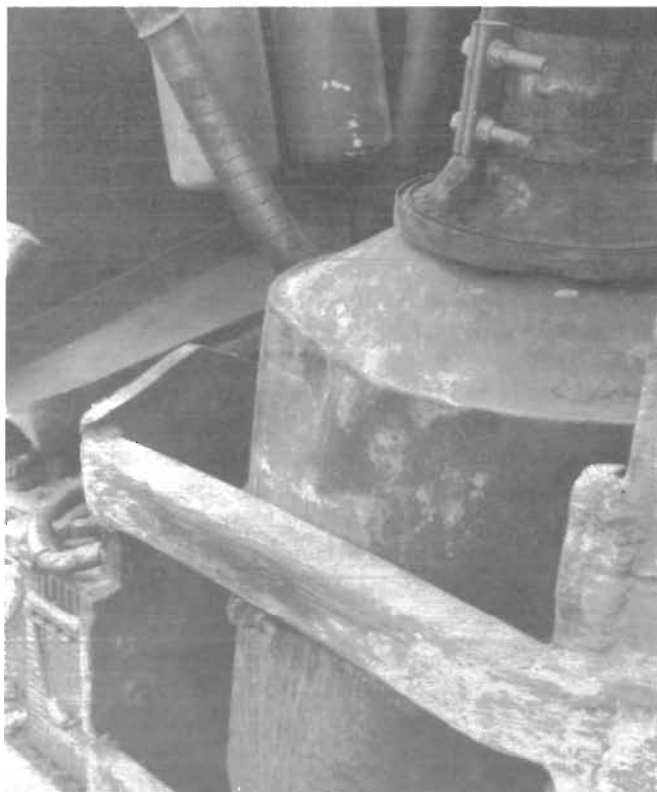
Figure 5.—Truck, 23.6 mt (26 t), with dent in CDPF.

The mine has five 23.6-mt (26-t) trucks with Caterpillar 3406 prechambered, turbocharged, and aftercooled engines that are equipped with CDPF's. The duty cycle of these trucks is probably adequate for the use of CDPF's, but these CDPF's are more susceptible to damage from operation and the mine environment. The trucks spend a significant portion of time operating under high-engine-load conditions such as being driven fully loaded up a 15-pct ramp. Temperature traces performed by the CDPF manufacturer indicated periods of time with exhaust temperatures above 400° C. However, full shift temperature traces were not recorded, so it is possible that regeneration is incomplete.

Regeneration problems and/or ceramic substrate damage are strongly suspected. Black exhaust smoke is frequently observed, the CDPF's have required pressure washing, and none of the backpressure alarms are functional. The CDPF's installed in these trucks are prone to damage due to impact against the mine rib. When a CDPF is hit, the substrate is frequently crushed at the point of impact, which affects filtration efficiency. Figures 5 through 7 show the damage sustained by a CDPF in use on a 23.6-mt (26-t) truck and by a CDPF that was removed from service.

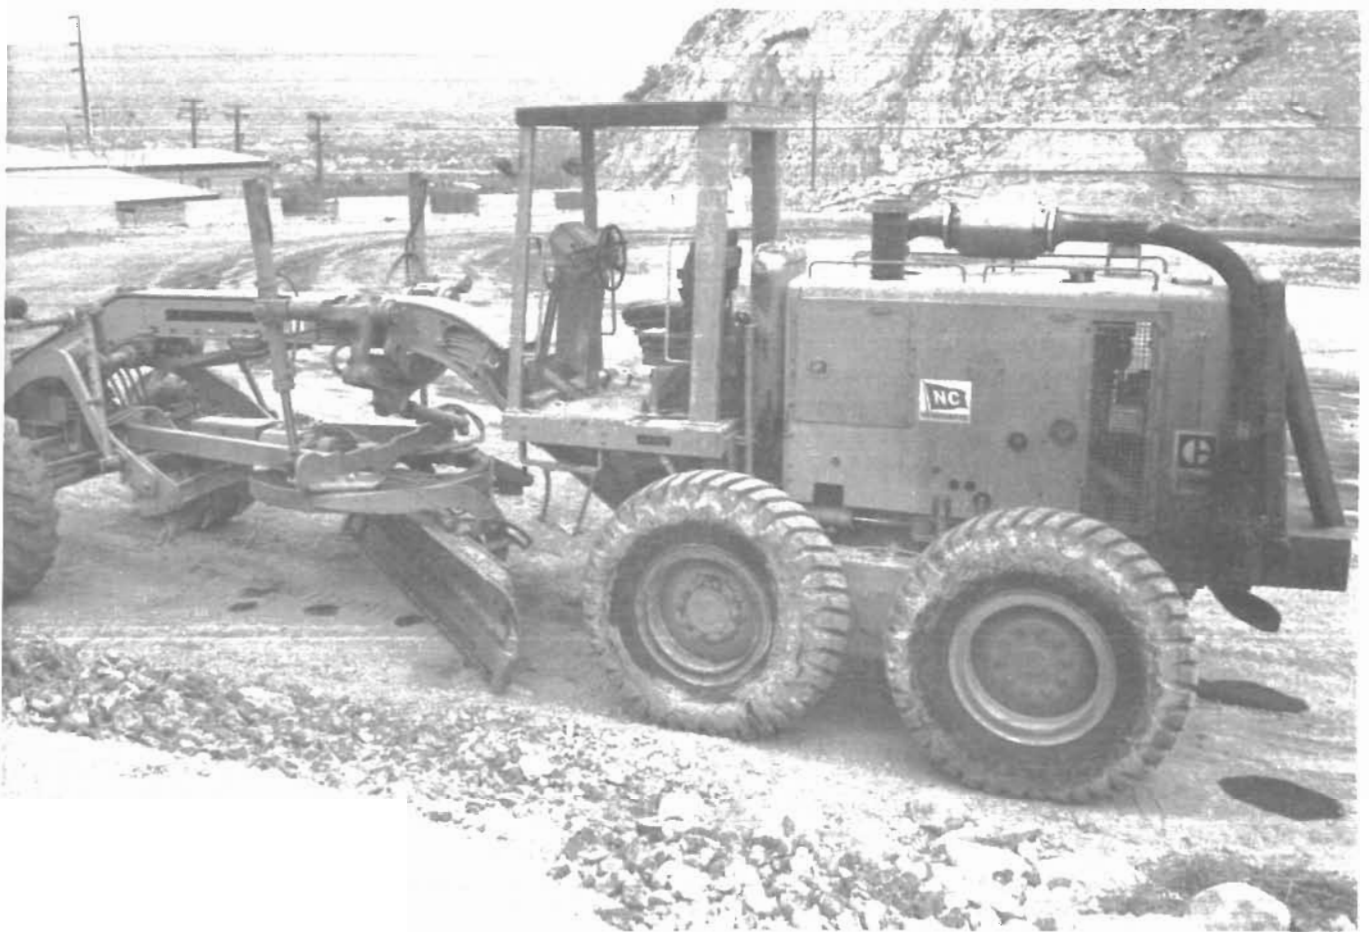
Figure 8.—Road grader with CDPF.

A CDPF was installed in April 1989 on a road grader (fig. 8) powered by a 93-kW (125-hp) Caterpillar 3304 engine at a cost of \$4,545 including the backpressure alarm. The CDPF failed in June 1992, after 1,671 h of use, although the backpressure alarm remained intact and appeared operational. For that period the cost of operation was \$2.72/h. The road grader's operating cost for 1991 was \$55.50/h, which included the cost of the CDPF. The cost of the CDPF represents 4.9 pct of the road grader's operating cost.

This CDPF showed a gradual decline in filtration efficiency, as increasing amounts of black smoke were observed in the exhaust stream. Several times the CDPF was removed from the road grader and pressure washed with water to remove some portion of the collected DPM and to reduce backpressure. After cleaning, visual observations suggested that the CDPF appeared to trap more of the DPM, but eventually the backpressure built up to unacceptable levels and further cleaning was required. At the time of the last cleaning, light could be seen through the CDPF and it was considered to have failed.
